Manhole Inspection Summary

Manhole # S41II_026MH

Insp Date: **12/28/07 10:52 AM**

Location Address: **1521 EDEN ST**

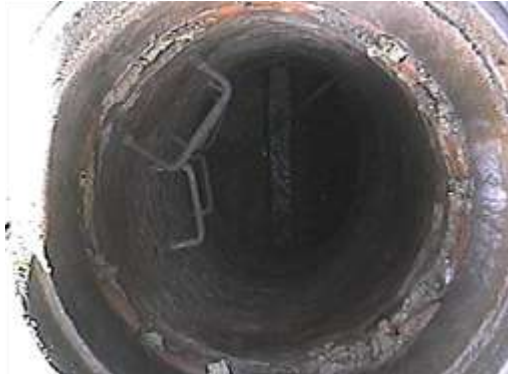
Defect 1

Frame Offset: **2** (in.) Condition: ☒ Sound ☐ Cracked ☐ Leaks

FRAME OFFSET

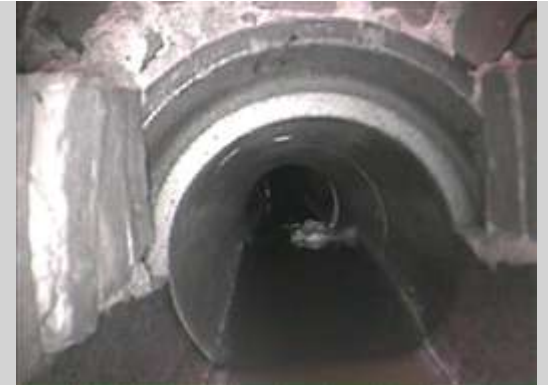
12 O'Clock Outflow

8 in. Circular Gravity Sewer
Pipe Out @ 12 O'Clock

Pipe Material: **Clay** ☐ Pipe Lined

Invert Depth: **10.51** (ft.) Flow Characteristics: **Slow**

Infiltration: **None** Pipe Seal Cond: **Sound**

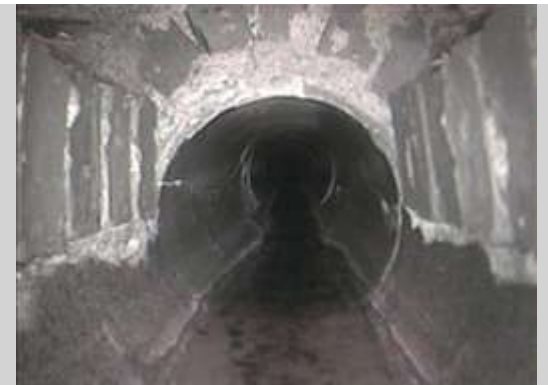
6 O'Clock Inflow

8 in. Circular Gravity Sewer
Pipe In @ 6 O'Clock

Pipe Material: **PVC** ☐ Pipe Lined

Invert Depth: **10.50** (ft.) Flow Characteristics: **Slow**

Infiltration: **None** Pipe Seal Cond: **Sound**
